# Financial Summary FY2010

Tohoku Electric Power Co., Inc.

# The Great East Japan Earthquake

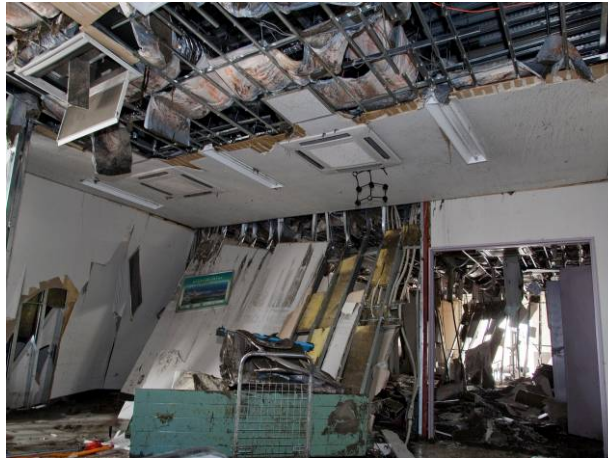
Sendai Thermal Power Station  
(located in Shichigahama-town, Miyagi Pref.)

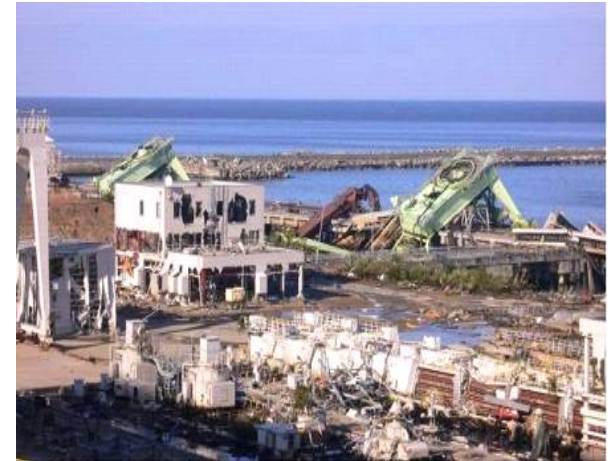
Haramachi Thermal Power Station  
(located in Minamisoma-city, Fukushima Pref.)

Haramachi	<ul style="list-style-type: none"> <li>· The service building was inundated up to the 3rd floor, control-cables were partly burned out</li> <li>· 4 coal unloaders and several heavy-oil tanks collapsed, all transformers were submerged</li> <li>· Electrical and mechanical facilities on the 1st floor were flooded</li> <li>· Outdoor buildings (except for the main building and service building) were devastated by the tsunami and swept away</li> <li>· Major equipment such as boiler and turbine has been checked in detail</li> <li>· ※Designated as "Evacuation-Prepared Area in case of Emergency" on Apr.22, 2011</li> </ul>

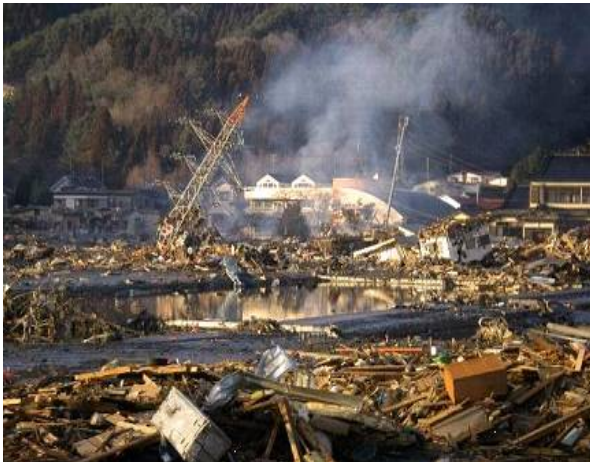
Transmission facilities (transmission line tower)  
(located in Otsuchi-town, Iwate Pref.)

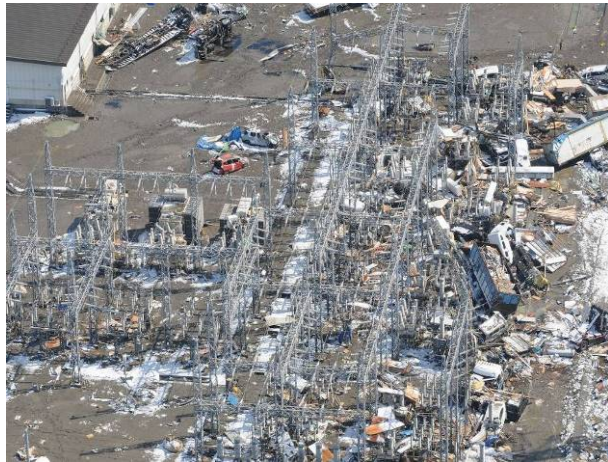
Tagajo Substation  
(located in Sendai-city, Miyagi Pref.)

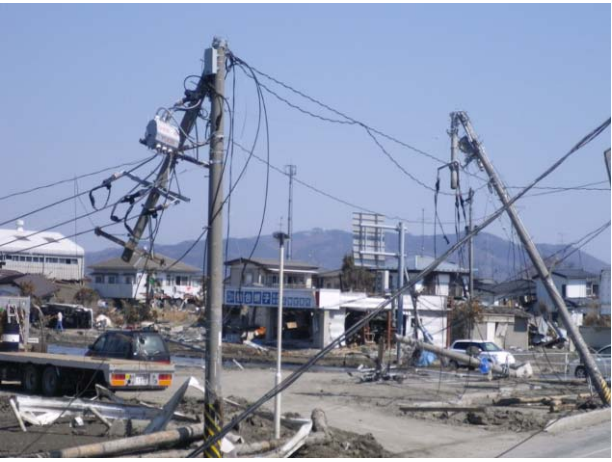
Distribution facilities  
(located in Ishinomaki-city, Miyagi Pref.)

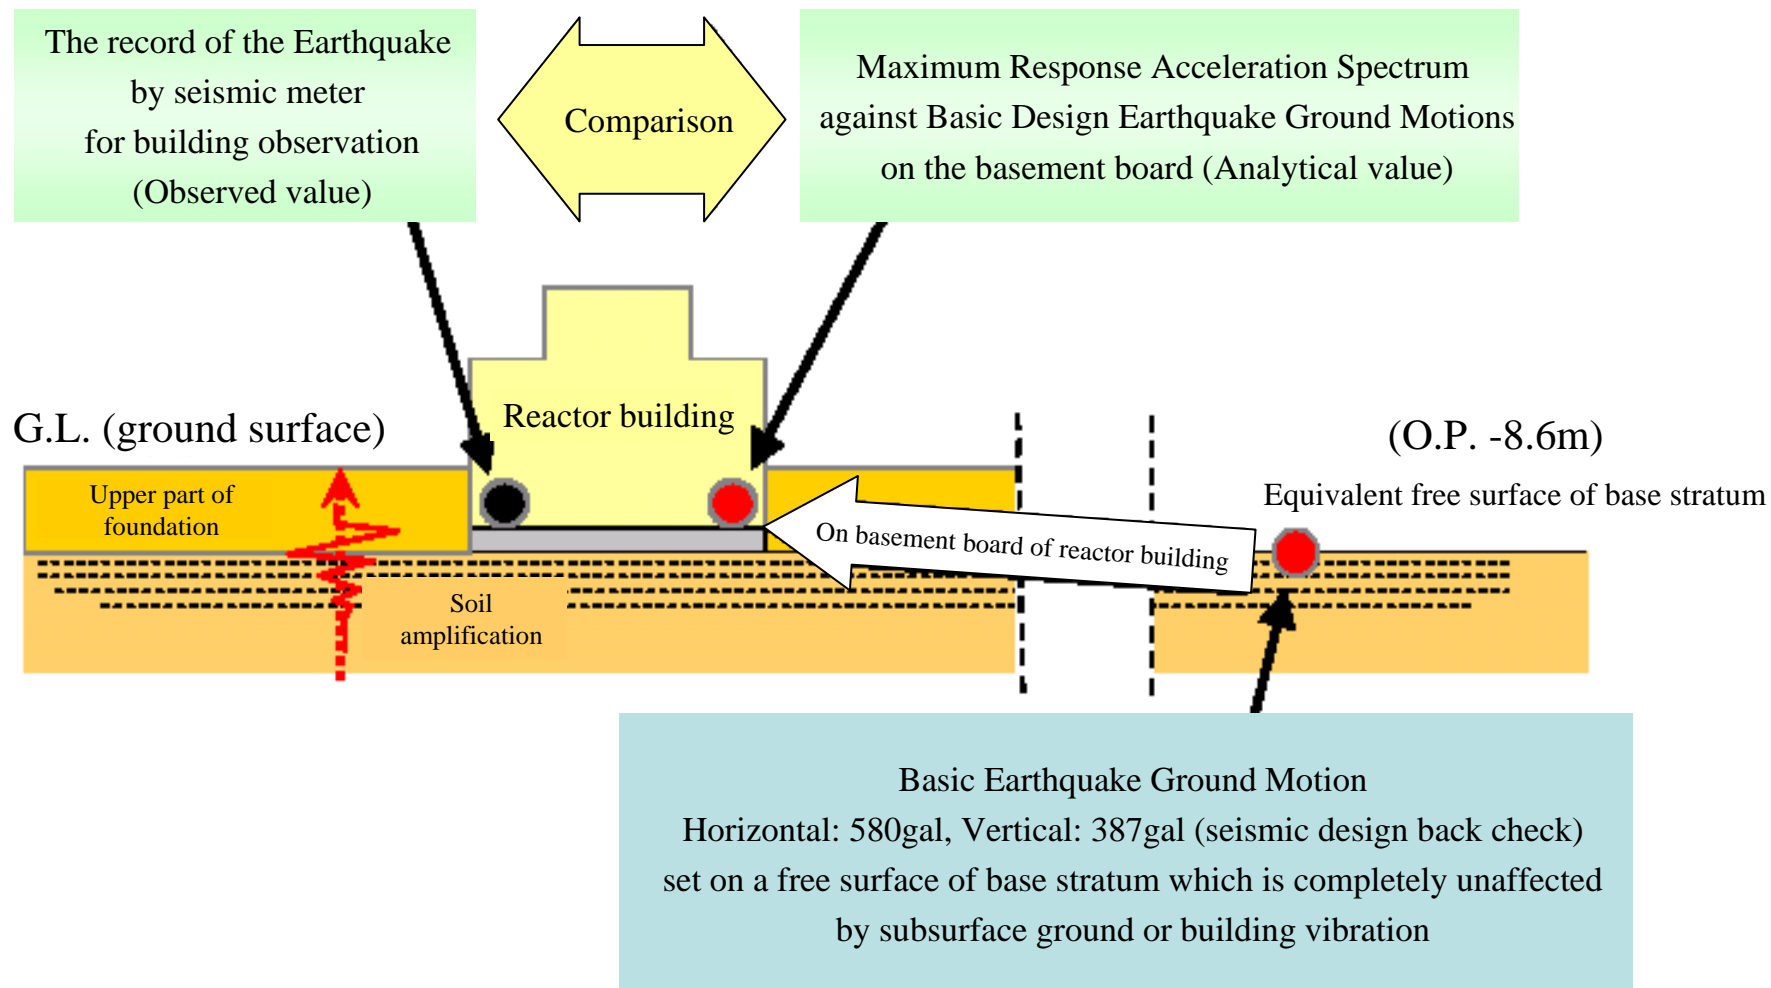
## The Comparison between Basic Design Earthquake Ground Motions and the Observed Record

O.P. → Onagawa construction base level (Tokyo Bay average sea water level -0.74m)

Although some of the maximum accelerations observed at Unit 1, 2 and 3 Reactor Buildings exceeded the maximum response acceleration calculated against the reference seismic movement Ss, they are virtually equivalent. It is confirmed that the reactor buildings are still able to function properly.

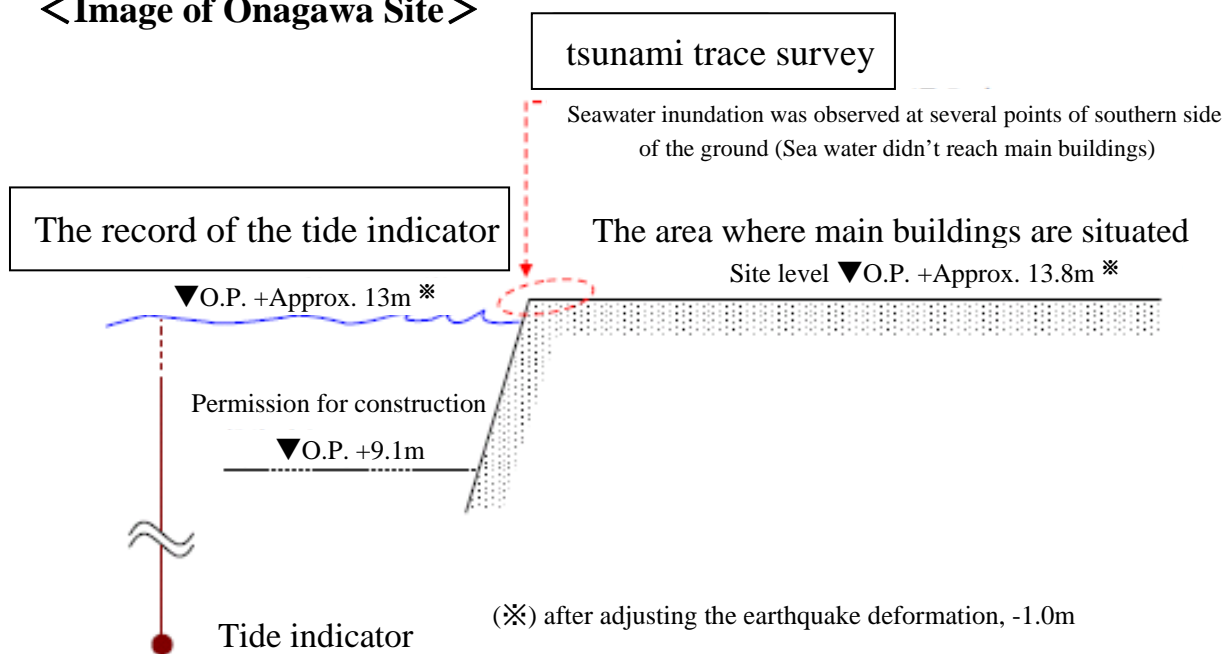
## <Image of Onagawa Site>

Site level	Tsunami water level required for permission for construction	Observed Tsunami water level
Onagawa	O.P. + 13.8m (※)	O.P. + 9.1m	O.P. + about 13m (※)
Higashidori	T.P. + 13.0m	T.P. + 6.5m	T.P. + 2.6m

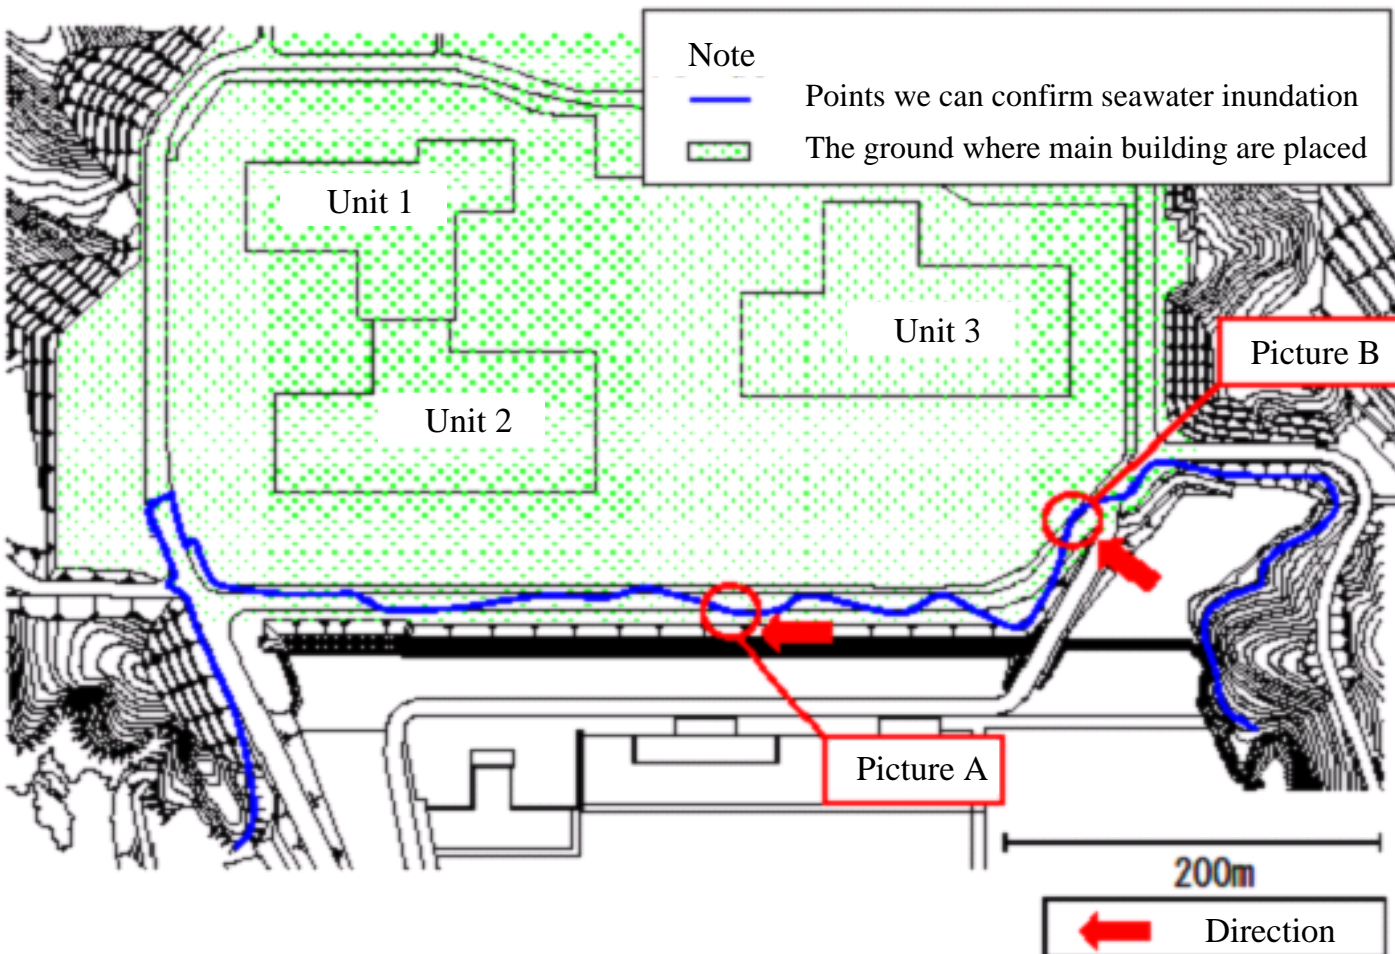
# Results of the Tsunami Trace Survey

Sea water didn't reach main buildings,  
but seawater inundation was observed at several points of southern side of the ground

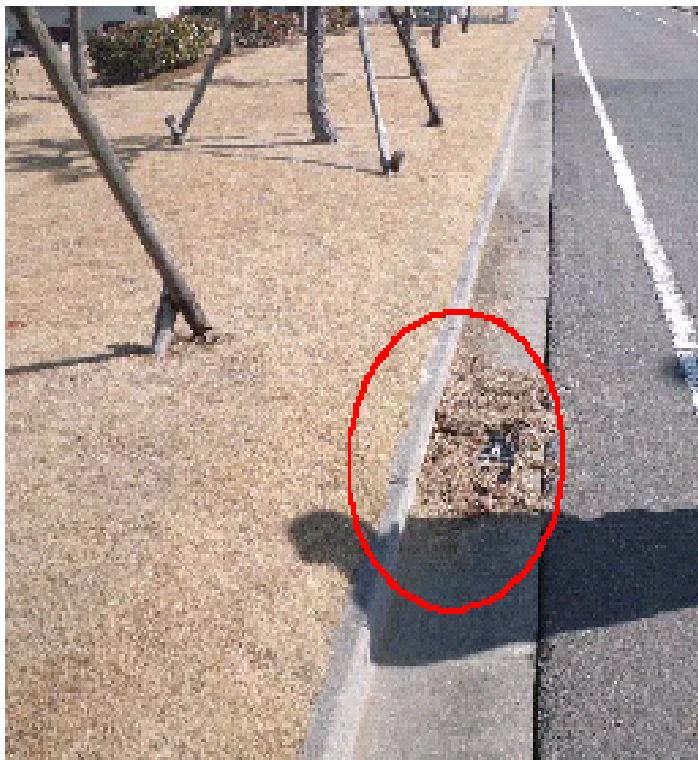
Picture A : The debris left on the road  
in Onagawa Nuclear Power Station

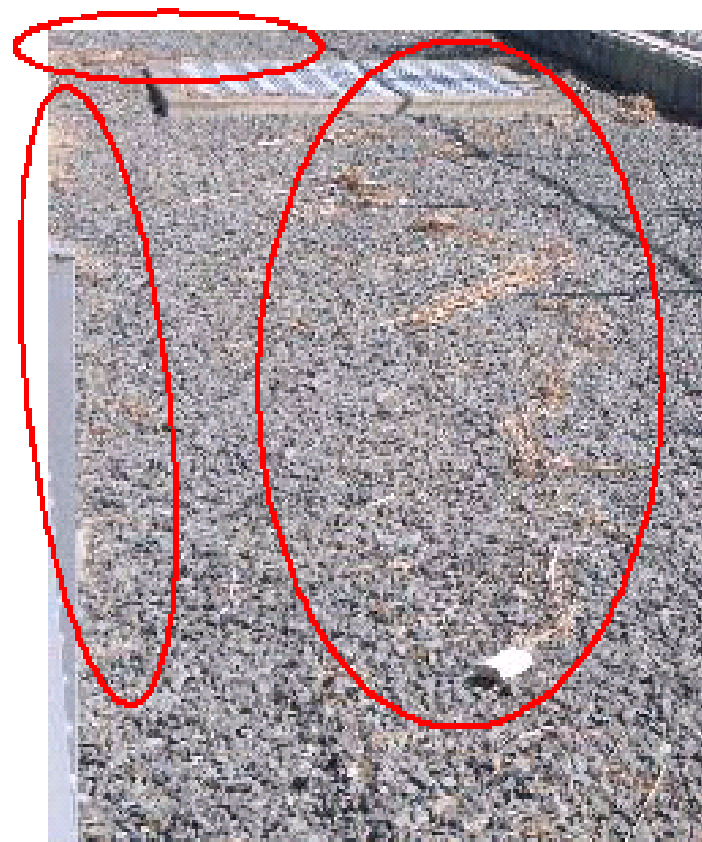
Picture B : The debris left on the gravel  
in Onagawa Nuclear Power Station

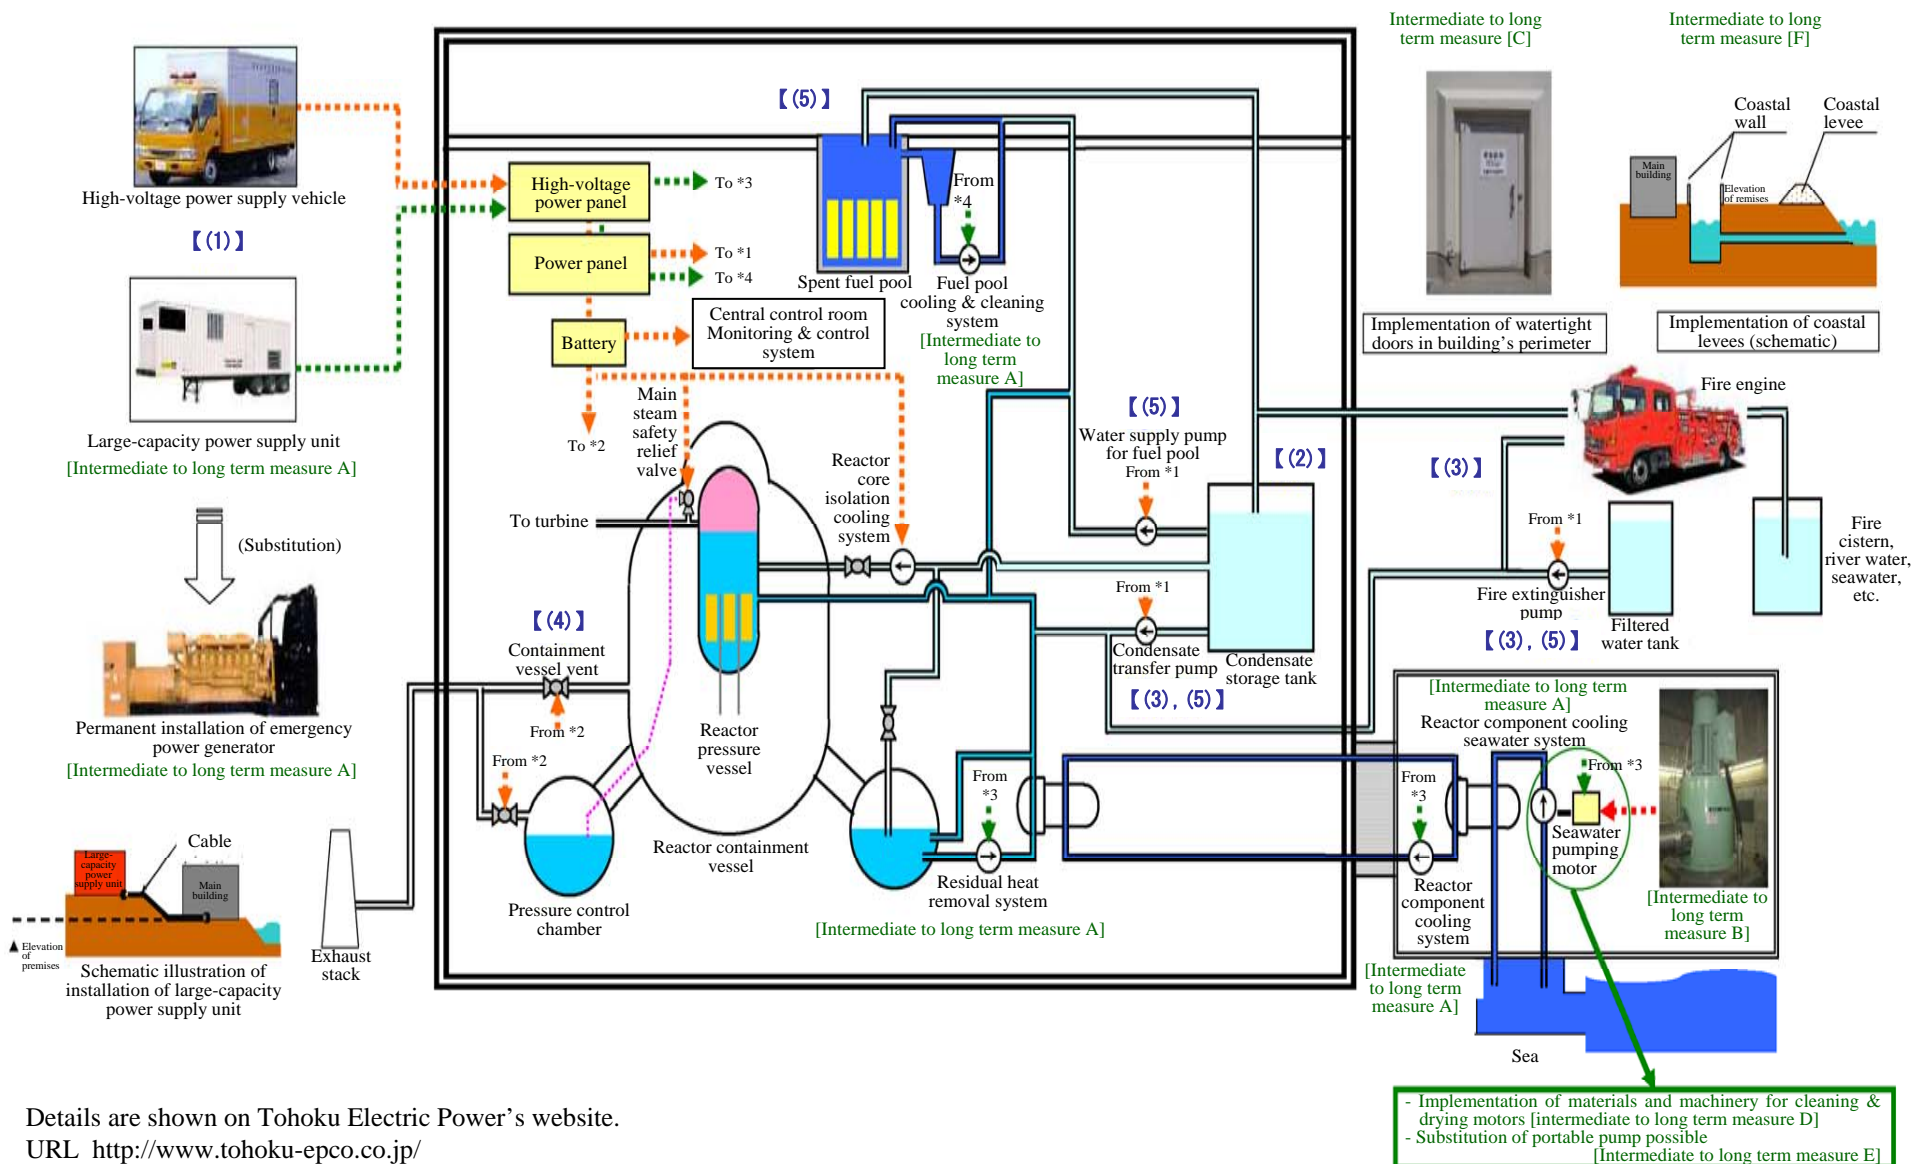
## Schematic illustration

- Implementation of replacement seawater pumps [Intermediate to long term measure E]
  - Securing backup motors for seawater pumps [Intermediate to long term measure B]
